SAS Superstructure

Daily Diary Report by Bid Item

Contract No.: 04-0120F4

Diary #: 788 Const Calendar Day: 262 Date: 21-Feb-2013 Thursday

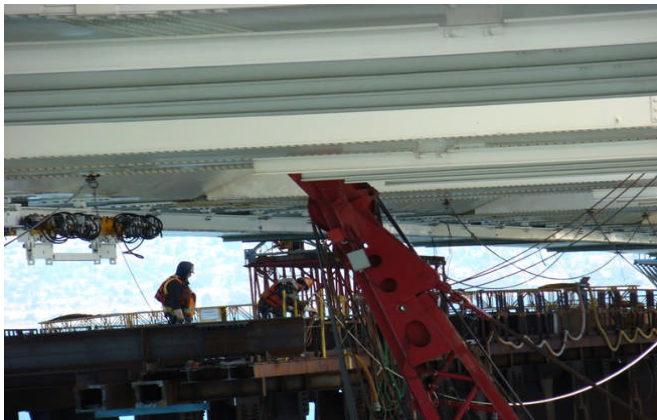
South Manitowoc ringer crane boom that contacted the bottom of the OBG and crossbeam.

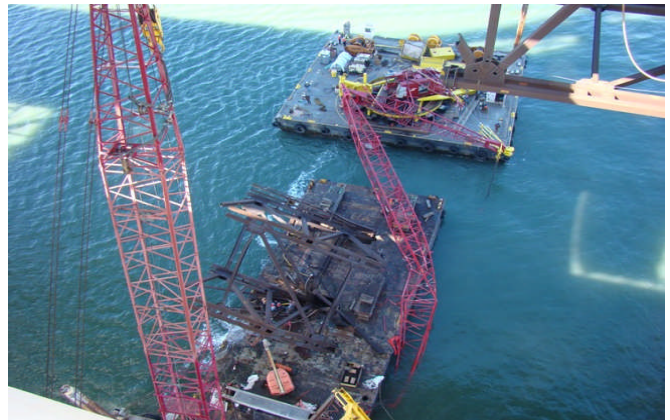
Crane collapse seen from the E-Line OBG looking north.

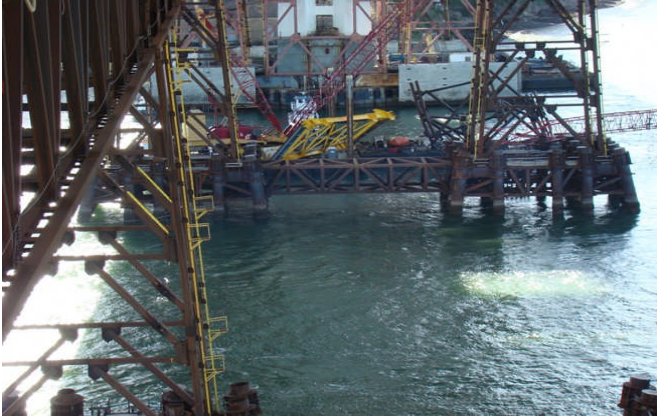
Accident scene seen from the E2 cap beam looking west.

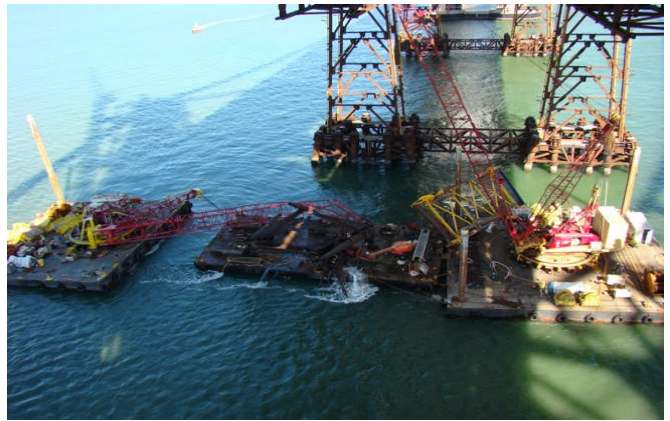
Manitowoc ring cranes, barges, and temporary truss section scene shortly after the accident.

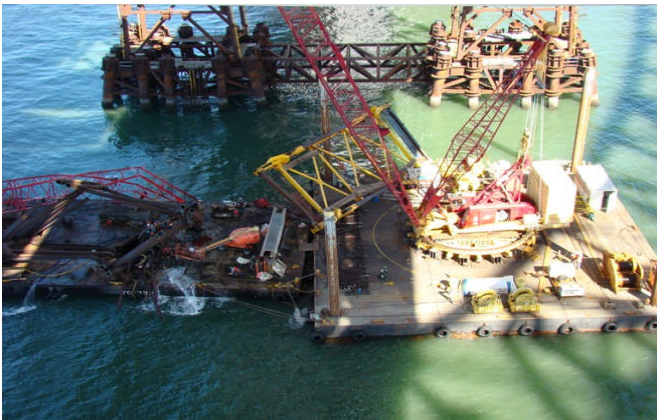
Crane collapse seen from the erection tower lower platform looking east.

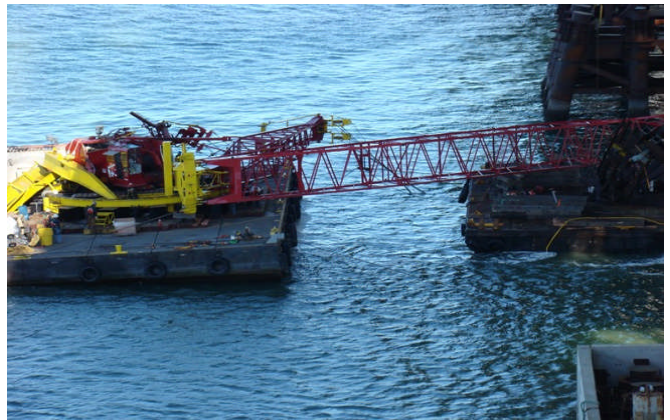
Overturned boom section of the North Manitowoc ring crane seen from the W2 cap beam scaffolds.

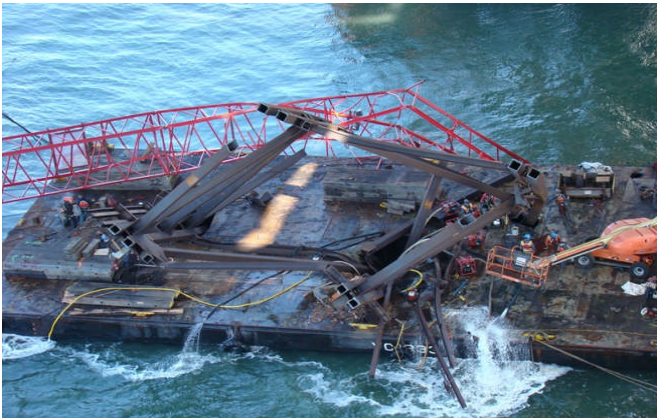
Mangled temporary truss section that fell and punctured the removal barge.

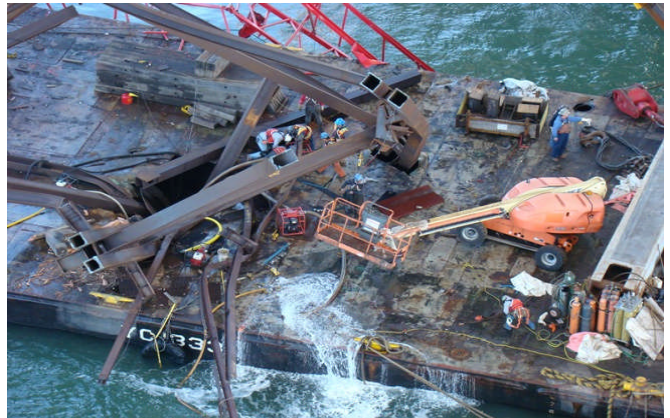
Close-up of the punctured barge from the temporary truss section that was dropped.

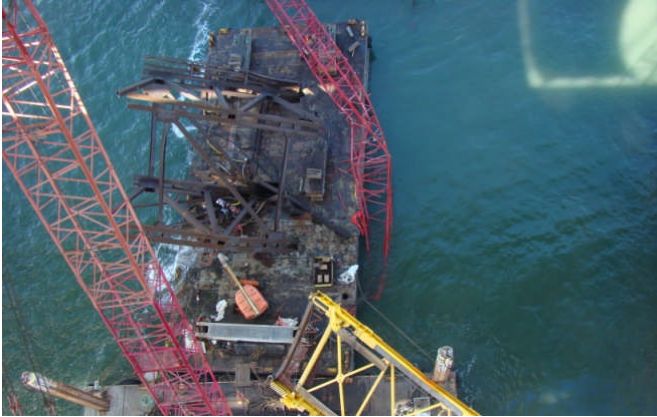
Crane collapse seen from the E-Line OBG looking north.

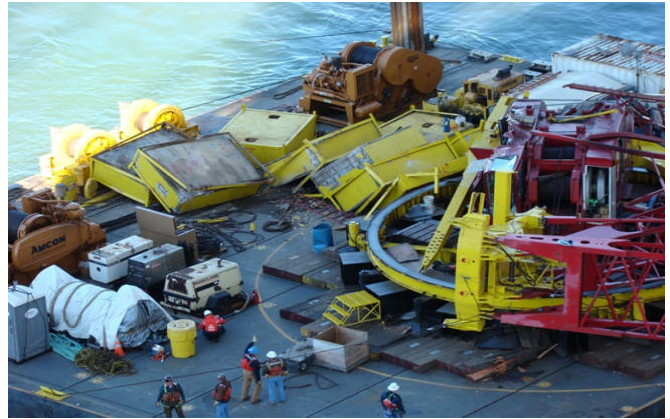
Counterweights on the north Manitowoc ringer crane that were hurtled from the back of the crane onto the barge.
